SCHOOL SEISMIC EVALUATIONS

PHASE 3 REPORT

WYOMING DEPARTMENT OF EDUCATION

J-U-B ENGINEERS, Inc.

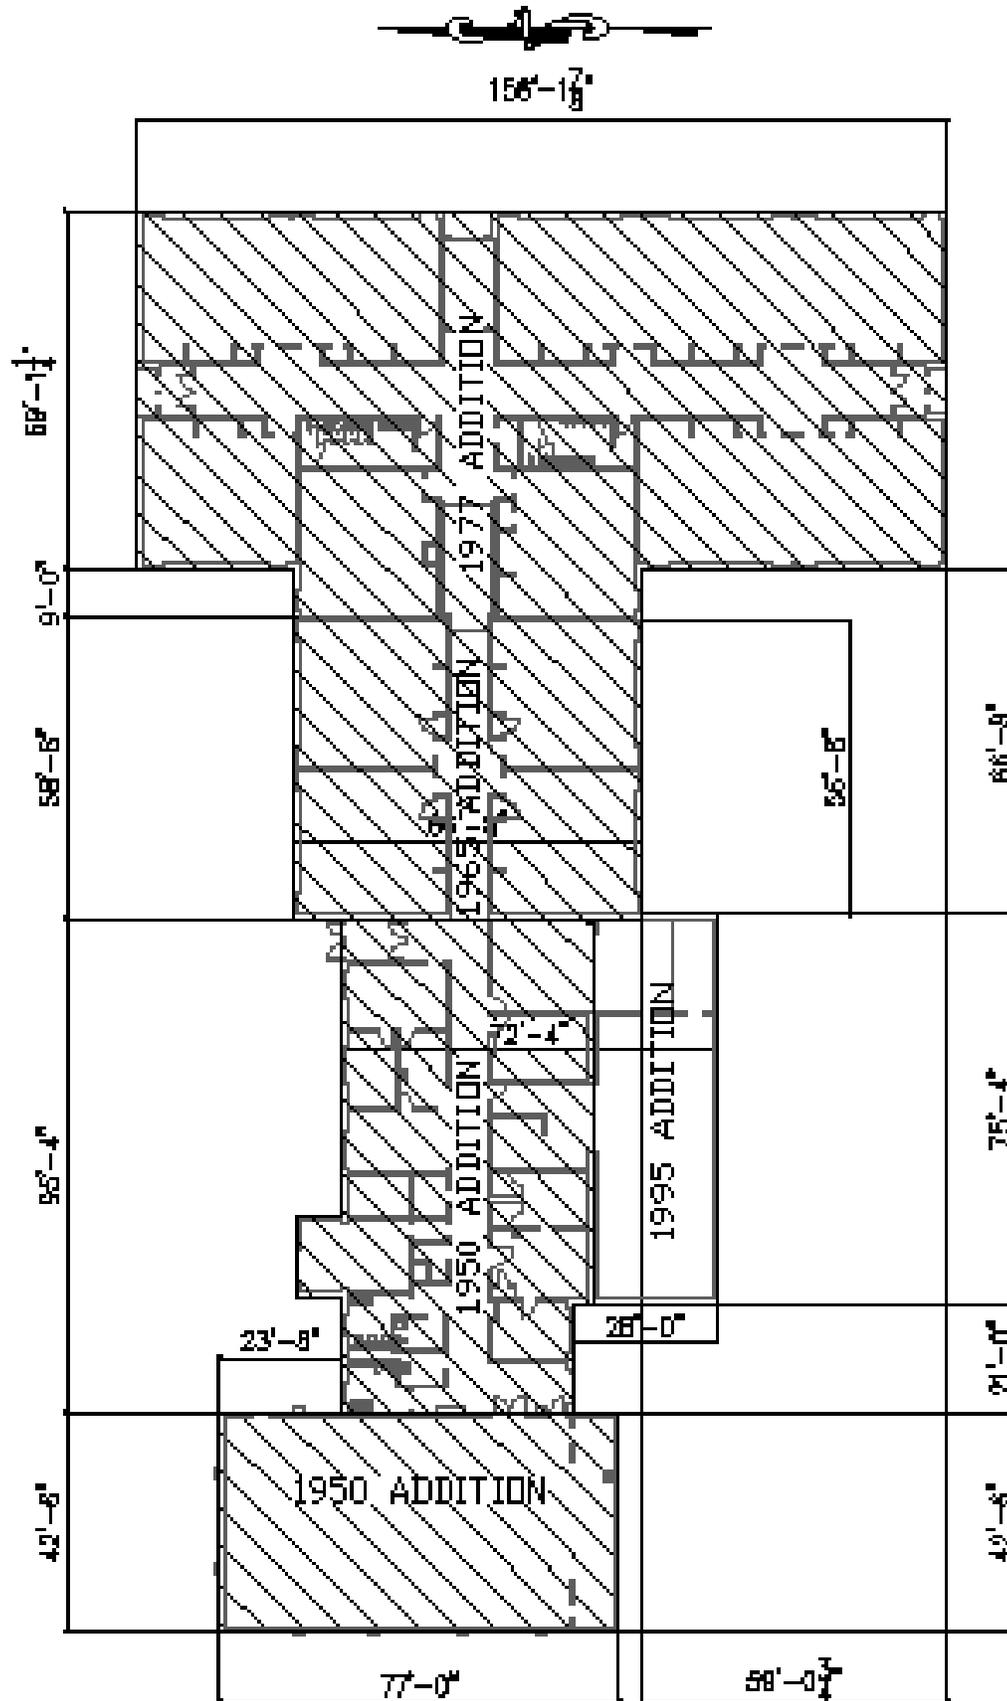
MAIN LEVEL - WITH DEFICIENT AREAS NOTED
 FILE: BURGOON-PLAN02.DWG

The basic structural deficiency this building is the lack of reinforcing steel in the masonry walls. This is because the building was constructed before minimum requirements for reinforcing steel in masonry walls in seismic area was required by the building codes.

This building will require extensive structural modifications to bring it up to compliance with current building code structural criteria. Virtually all unreinforced brick and masonry walls, both interior and exterior of the building, will need to be removed and replaced or otherwise strengthened to resist lateral forces. Existing roof diaphragm perimeter connections, and chords will need to be reconstructed in order to provide a complete load path for lateral forces from the roof to the foundation.

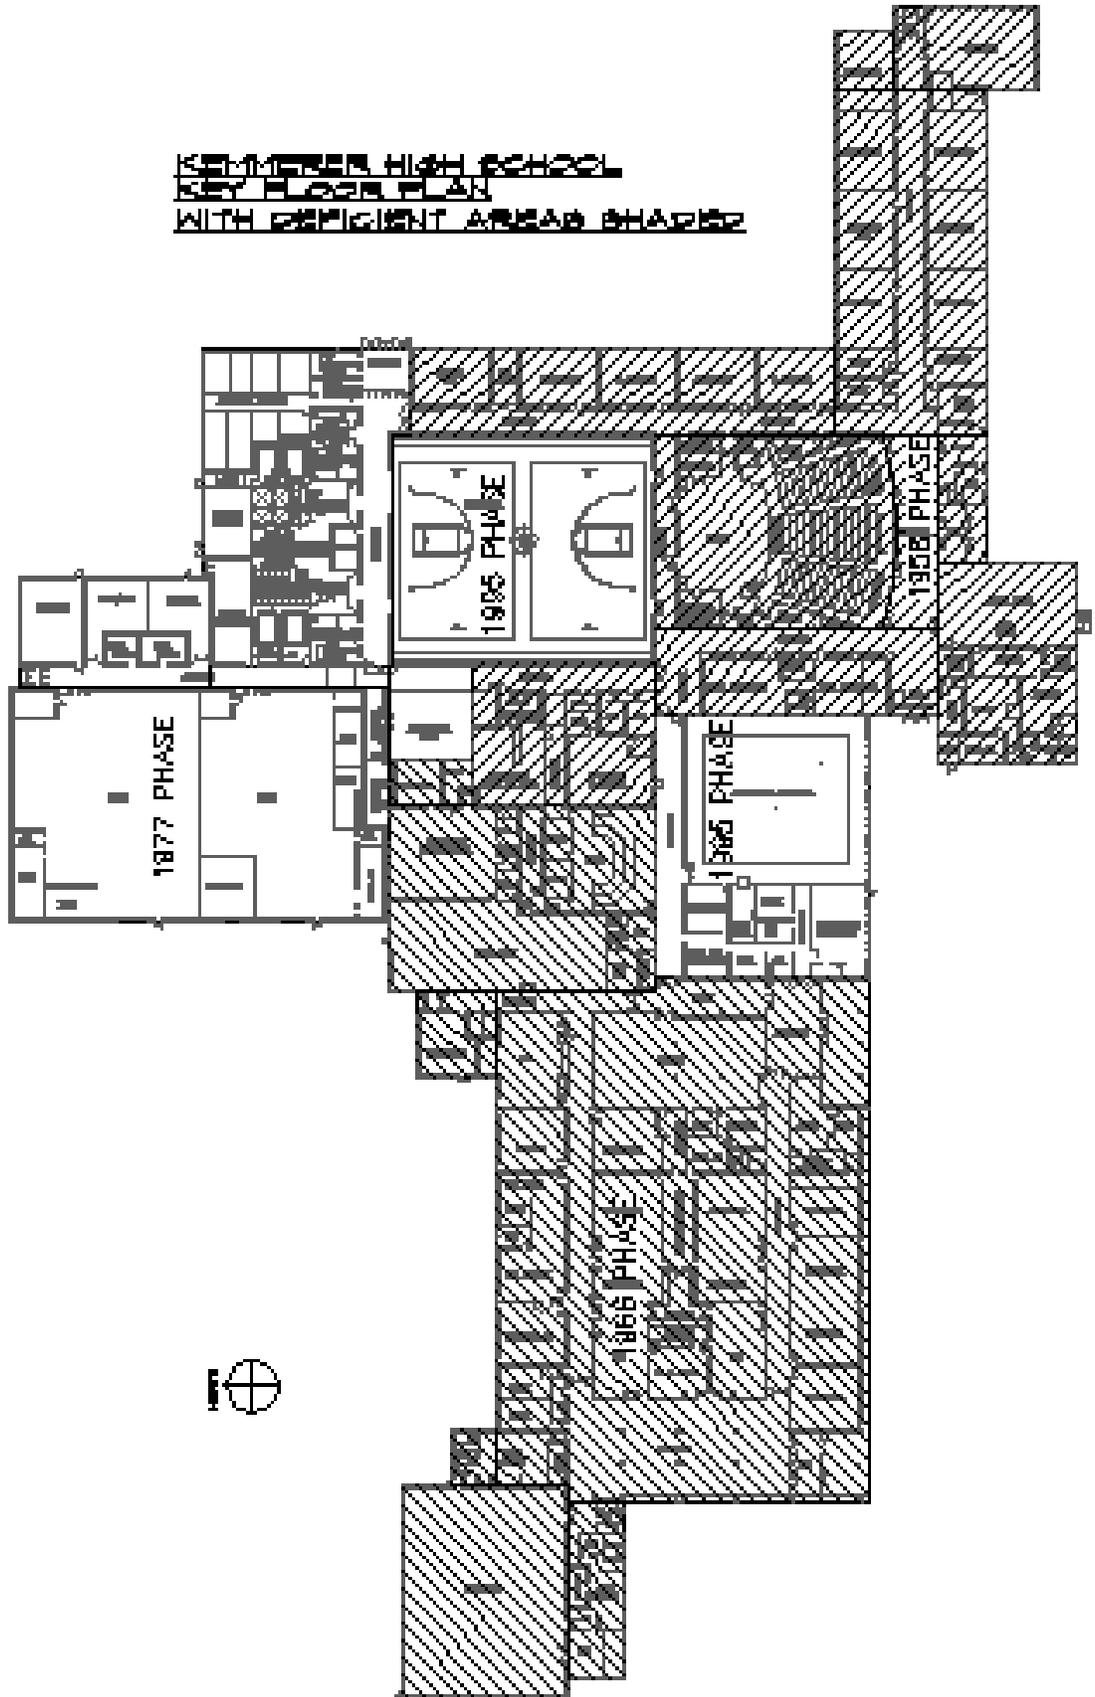
**KEMMERER HIGH SCHOOL
KEY FLOOR PLAN
WITH DEFICIENT AREAS HATCHED**

Phase 1 (1958). The principal deficiencies found in the 1958 portion of the building are attributable to the fact that it was built without specific attention given to the effects of lateral (earthquake) loads. Of primary concern is the number, size and construction of walls that must serve as shear walls. Other than the Auditorium, which is surrounded by solid masonry walls on all four sides and the kitchen area, most of the building utilizes large expanses of window wall with only short sections of masonry that might serve as shear walls. Where exterior masonry walls are present, they are too short in length, too few in number or spaced too far apart to resist the estimated shear forces. In addition the masonry is basically un-reinforced, which is not permitted by current code structural criteria.

All shear, bearing and in-fill walls consist of either un-reinforced brick, or a combination of un-reinforced brick and concrete masonry. Many of the walls are simply in-filled brick walls between the steel posts that support the roof framing with no specific attachment to the roof framing, the steel columns or the foundations. Earthquake type lateral forces acting either in-plane or out-of plane to the walls will create high-tension stresses within the walls. Tension stresses can't be resisted effectively by un-reinforced masonry.

Phase 1 (1958). This phase of the building will require extensive structural modifications to bring it up to compliance with current building code structural criteria. Existing un-reinforced brick and masonry walls will need to be removed and replaced or otherwise strengthened to resist lateral forces. Essentially all exterior walls bearing walls have insufficient shear wall length and new shear walls or braced frames will be required at several interior locations. All roof diaphragms and chords will need to be strengthened and properly attached to new shear walls in order to provide a complete load path for lateral forces from the roof to the foundation. Foundations effected by new shear walls and/or braced frames will also need to be strengthened and/or added where required.

Phase 2 (1966). This phase of the building will require extensive structural modifications to bring it up to compliance with current building code structural criteria. Virtually all un-reinforced brick and masonry walls, both interior and exterior of the building, will need to be removed and replaced or strengthened to resist lateral forces. New shear walls or braced frames will need to be added at selected locations. All roof diaphragms, perimeter connections, and chords will need to be reviewed with the final shear wall plan and strengthened and or added to provide a complete load path for lateral forces from the roof to the foundation. Foundations effected by new shear walls and/or braced frames will also need to be strengthened and/or added. The exact extent, number and location of new/or strengthened structural elements can only be determined through a complete structural design performed by a structural engineer familiar with this type of work.

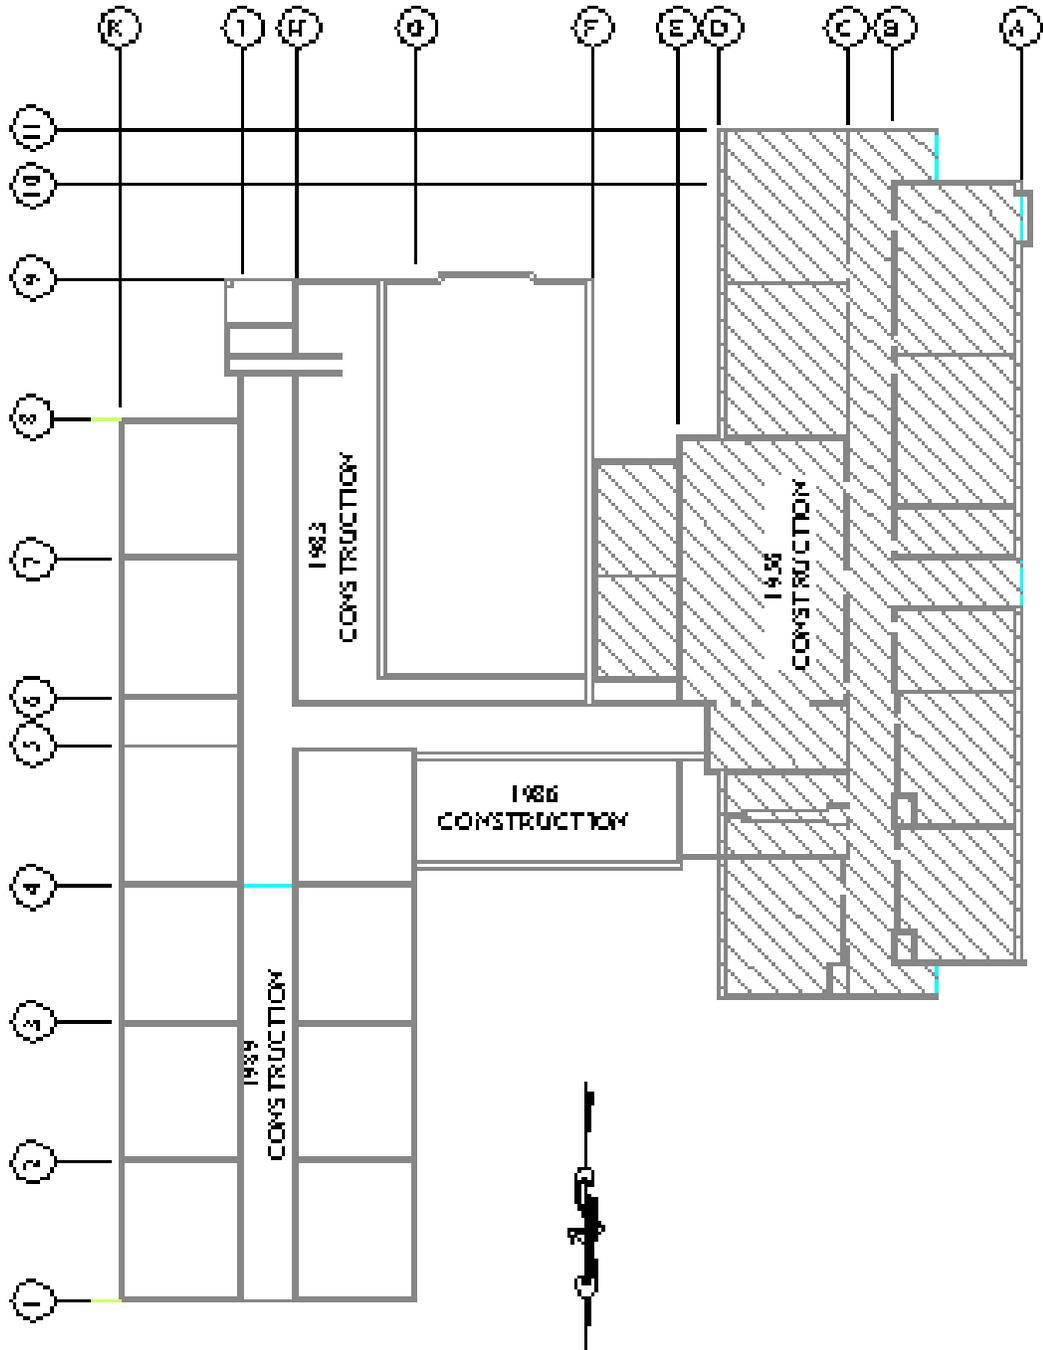
HOLDAWAY ELEMENTARY SCHOOL THAYNE, WYOMING

Phase 1 (1956). As mentioned above, the majority of the concerns with this phase stem from the fact that it was not specifically designed with earthquake loading in mind. The principal potential deficiencies pertain to the type of construction material used for the roof diaphragm and the bearing/shear walls.

In general, in the North-South Direction and along the interior corridor walls there is sufficient length of shear walls to resist seismic loads, though the amount of reinforcing provided in the walls does not meet current minimum code requirements. In the East-West direction the exterior sides side-walls are of insufficient length to resist seismic loads and the in-fill walls that were constructed during later phases of construction were not designed and detailed to properly act as shear walls. Shear walls that have insufficient reinforcement may fail due to out of plane forces rather than in shear.

NOTE: SHADING INDICATES AREAS WITH STRUCTURAL DEFICIENCIES PERTAINING TO SEISMIC DESIGN CRITERIA.

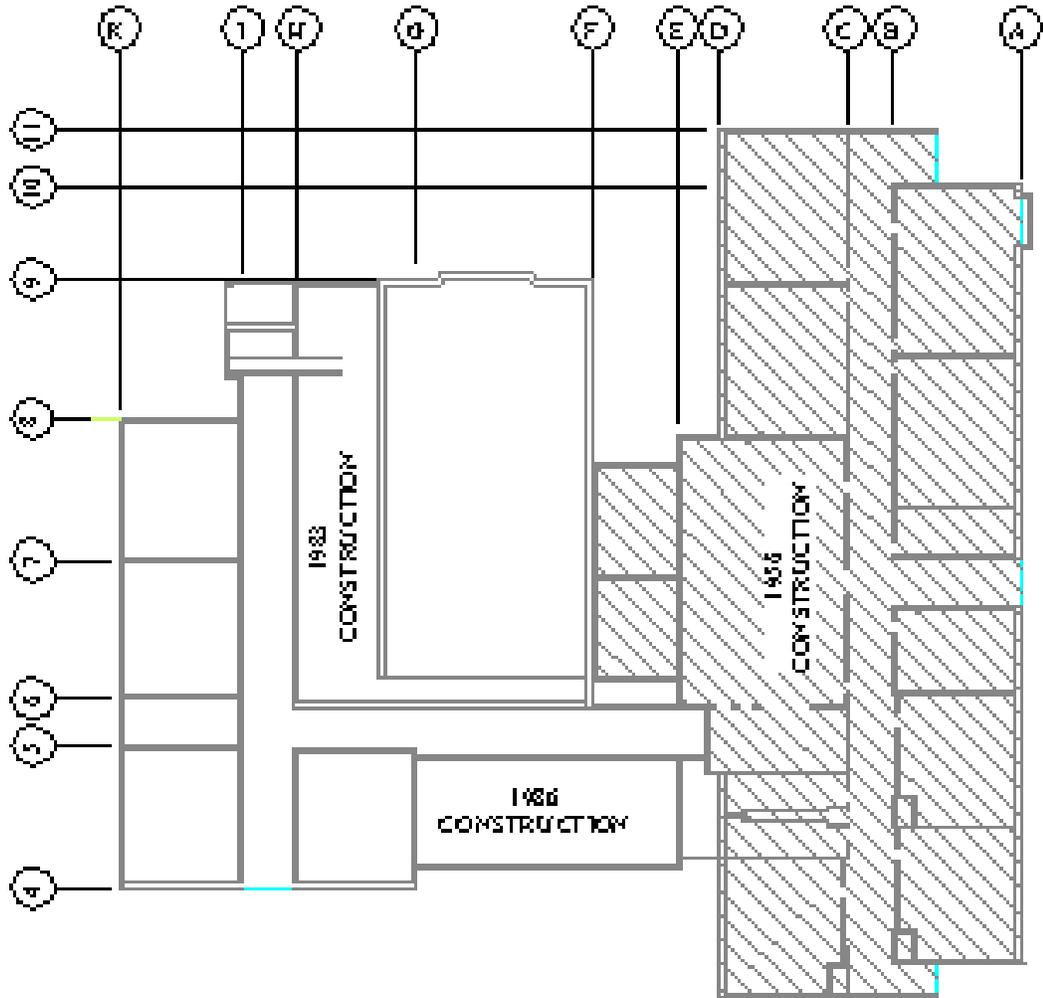
METCALF ELEMENTARY SCHOOL
ETNA, WYOMING

NOTE: SHADING INDICATES AREAS WITH STRUCTURAL DEFICIENCIES
PERTAINING TO SEISMIC DESIGN CRITERIA.
